GARFIELD FARM MUSEUM VOL. 26 December 2009 NO.2 BOX 403 LaFOX,IL 60147-0403

SOUTH WALL OF 1842 BARN RESTORED

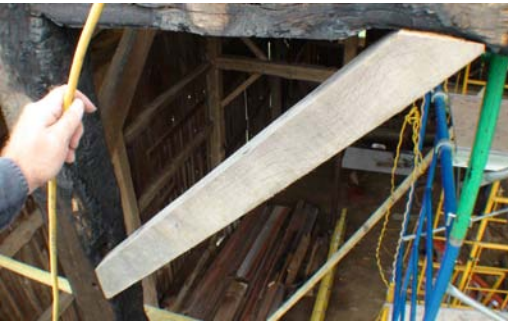
Finally, the crew of TDT arrived and started removing and labeling the siding. Once exposed the fire damage

was even less than feared. Ultimately one half rafter, a nailer (a cross piece to attach the siding between beams),

and an angle brace had to be replaced. Opening up the wall revealed the real damage over time. Both the sill (the beam that sits on top of the foundation and

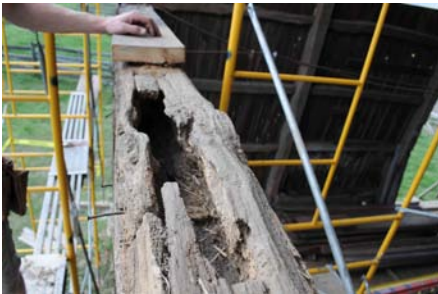
the cross tie beam about 8 feet above, had serious cases of hollowing and rot in their mid points. The cross tie beam especially needs to carry weight so the

first thought was to lap in (scarf in) and replace that portion with new or a salvaged beam. Just filling the hollow with epoxy resin would not be enough. Discussion eventual produced the idea of using shear rings to fix a metal plate with lag bolts into the beam. Imagine the shear ring like a donut and then cutting out the wood so the ring sits flush with the surface.

This provides more surface contact and strength than just a lag bolt anchoring the metal plate at each end. The metal plate was put on the beam side facing the siding and thus hidden from view. The hollows were epoxy filled. With the 3 ½ stories of scaffolding, it was possible to get up close and personal with the barn's roof system. Azemi and Sons, who will restore the roof, agreed with TDT that before the roof could be done,

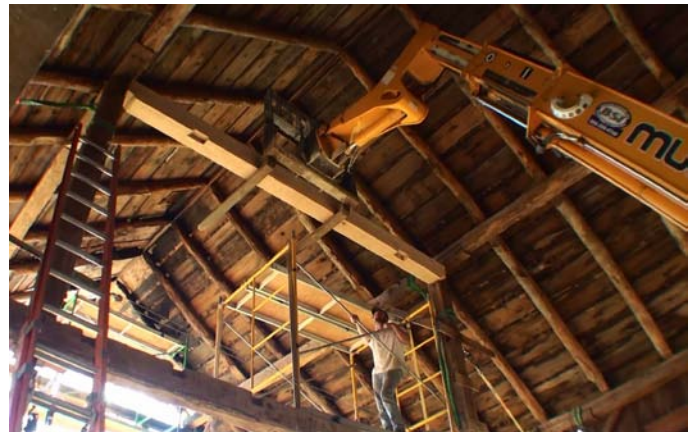
the beams supporting the rafters needed to be leveled. Presumably sometime after 1864 when the barn was moved intact to the hillside by the road across from present day Burr House (the visitor center), a hay carrier fork system was installed to efficiently fill the hay mows. However, a beam or girt that housed floor joists for a loft and two restraining beams that held the upright beams that supported the roof had been cut out to make way for the hay carrier. Right here was the start of structural compromise for this barn. To level the roof, the purlins and plates, these beams had to be installed. This was the most unnerving step. To fit a beam in, the barn had to be pulled apart at least 4-6 inches. Using a series of straps and "come alongs" (simple wenches) the crew carefully but steadily pulled the top side walls outward. You could actually see these massive beam systems move! One kept waiting for a pop or collapse or at least the overturning of the work truck to which some of the strapping was anchored. Now no crew of two is going to shoulder a 500 pound plus green oak beam up 2 stories on ladders. Just fitting, a large forklift was gingerly driven into and between the beams of the barn to do the lifting. Again, breath was held during this procedure. Now when the roof is restored, 2-3

inch shims that were installed in the 1983 roof repair to level the roof line can be removed as the rafters will go back into place roughly where they were 167 years ago.
